Repair manual BIOSTAR® 4-Aligner

6 CMOS battery replacement

ERROR 007 Die The battery voltage is below 2,8 V → Replace the CR2032 button cell

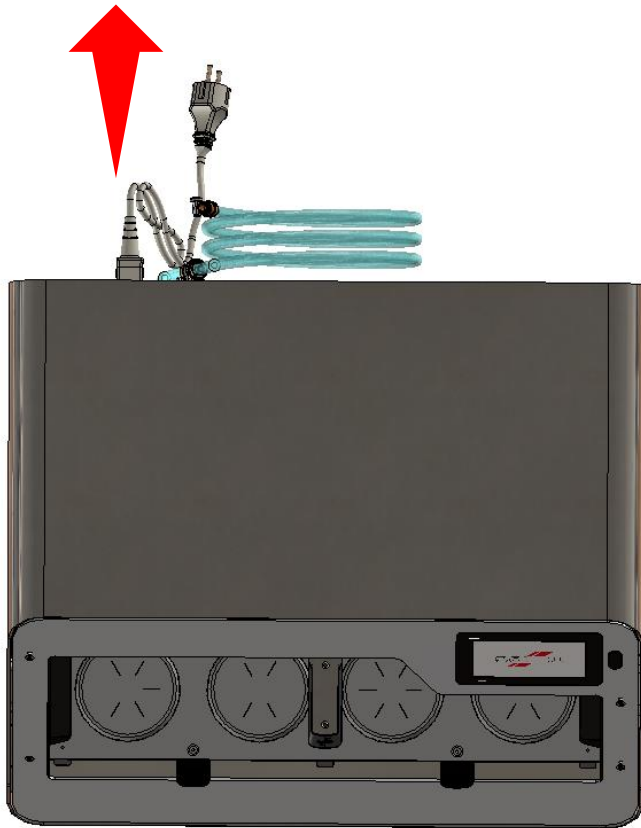
1 DISCONNECT THE DEVICE FROM THE POWER SUPPLY!

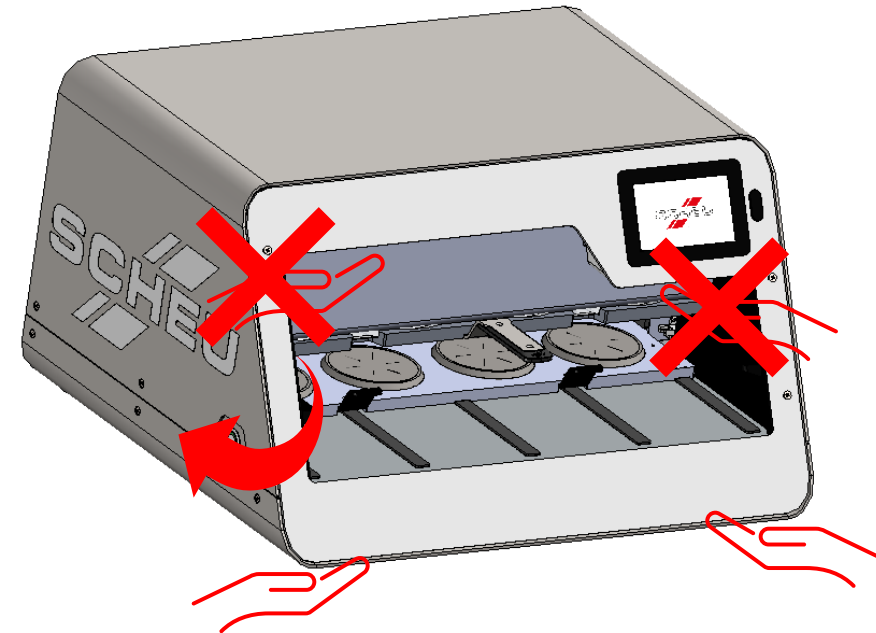
2 Turn the appliance so that you can reach the screws on both sides.

Do NOT lift the device by the FRONT panel but reach under the device!

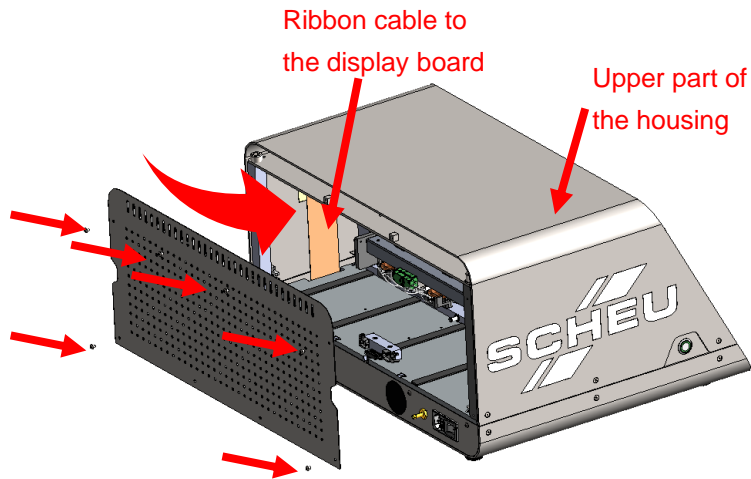
- 3** Remove the 6 screws from the rear panel. Then press on the side of the upper part of the housing to carefully detach the ribbon cable from the double-sided adhesive tape on the upper part of the housing.

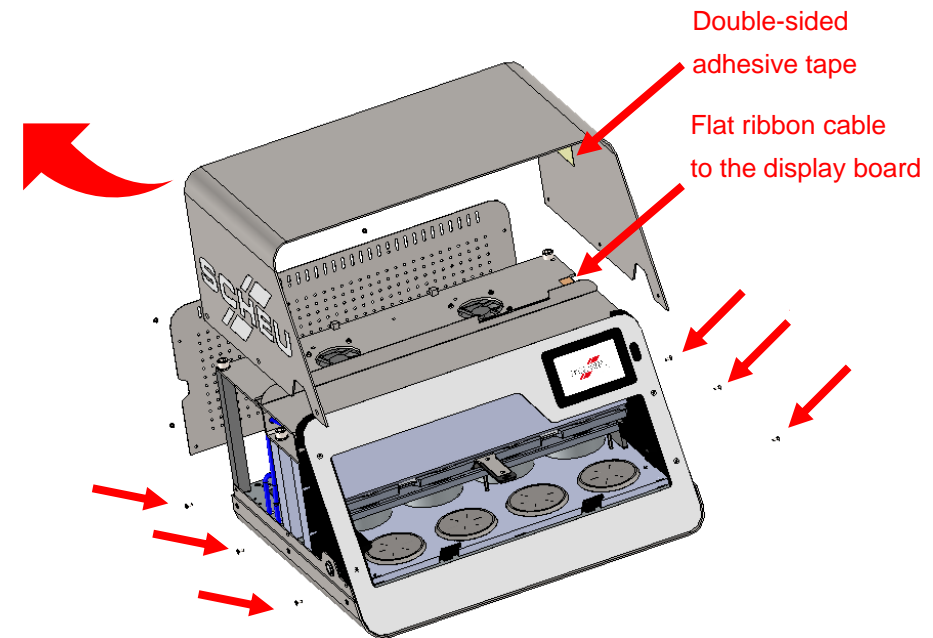
- 4** Remove the 6 screws from the upper part of the housing. Caution! If necessary, remove the ribbon cable from the adhesive tape again.

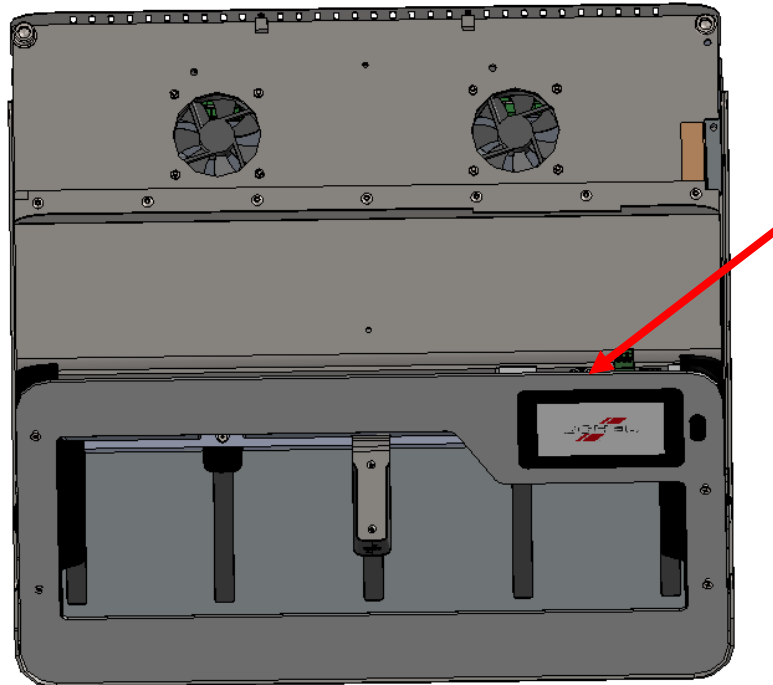
5

The battery is located here for replacement.

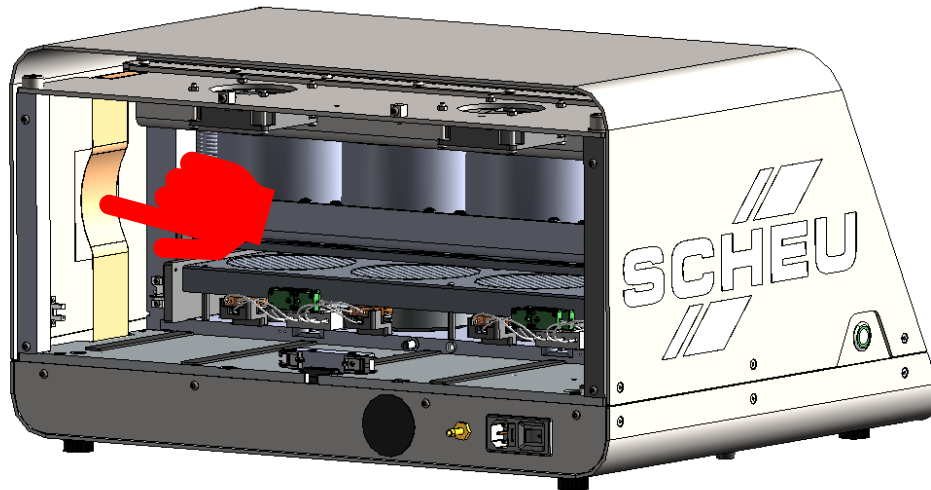
Slide on the upper part of the housing and screw it to the side with the 6 screws. Then press the ribbon cable onto the double-sided adhesive tape on the upper part of the housing. This prevents the ribbon cable from becoming entangled with the reflector plate and, in the worst case, from being pulled off.

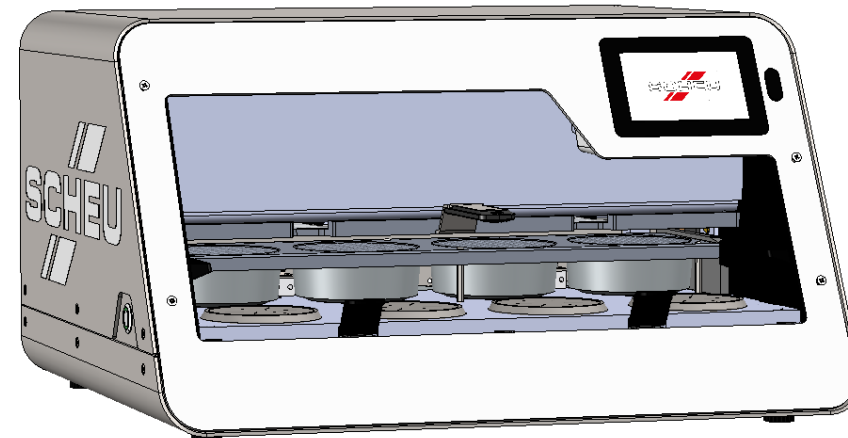
7

Now fasten the back panel with the 6 screws.
